# Hughes Warehouse Adaptive Reuse

## Project Overview

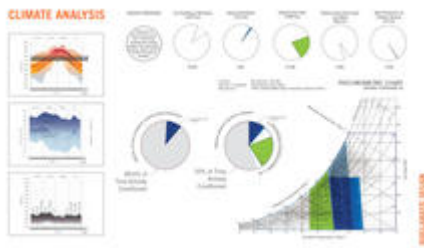
# Bioclimatic Design

Honoring the history of the building, the design team left the existing double wythe brick walls mostly intact but improved thermal insulation through the addition of R20 rigid roof insulation. The roof was upgraded to a reflective TPO cool roof to mitigate heat gain. Though the original steel frames surrounding the clerestory windows would only accept 1/4-inch laminated safety glass, the new punched windows and curtain wall feature one-inch-thick Solar Band 70 XL coated high-performance glass. Steel window box shades surround the windows along the east and west facades. To mitigate solar gain, the new shades are extruded about a foot on the east side of the building, and about two feet on the west. The clerestories and courtyard curtain wall are equipped with translucent, automated shades that control glare without obscuring views and also abide by the astronomical clock. These combined shading strategies have reduced the amount of time that requires active conditioning by 18.5% per year. The courtyard curtain wall illuminates interiors but is shaded by the preexisting south façade, preventing direct glare. A 65 kW photovoltaic rooftop array generates approximately 46% of the energy needed for building operations.

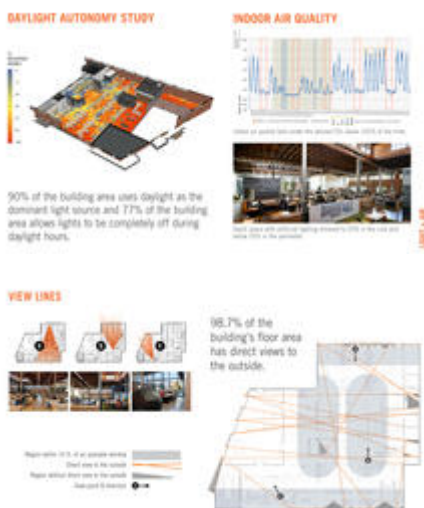
## Light & Air

Other than clerestory windows and several loading dock entries, the building was entirely encased in a double wythe brick wall. While the clerestories provided daylight to the interior, they provided only views to the outside of the sky and did not facilitate the transition from streetscape to interior. By adding punched windows along the east and west facades and a glass curtain wall to the newly inserted courtyard, views to the outside are available in 98.7% of the floor area. Additionally, the clerestories, which had been painted over, were made

operable once again, providing natural ventilation to building occupants when desired. 60% of the office floor area is within 15 feet of an operable window, accessible to 48 of 77 full-time employees. CO2 meters monitor indoor air quality, which fall below the threshold for indoor CO2 levels.

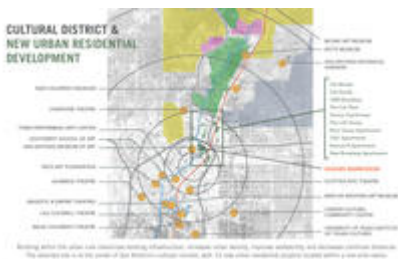
Showing the layout of the building, the design team used the existing building footprint to create a new design. The design process is a continuous and iterative one, with many changes and iterations. Building 10, and the site plan, show the final design.
